FLOODS OF JUNE 1965

SOUTH PLATTE RIVER BASIN,

COLORADO AND NEBRASKA

U. S. ARMY ENGINEER DISTRICT, OMAHA
CORPS OF ENGINEERS
OMAHA, NEBRASKA
JANUARY 1967

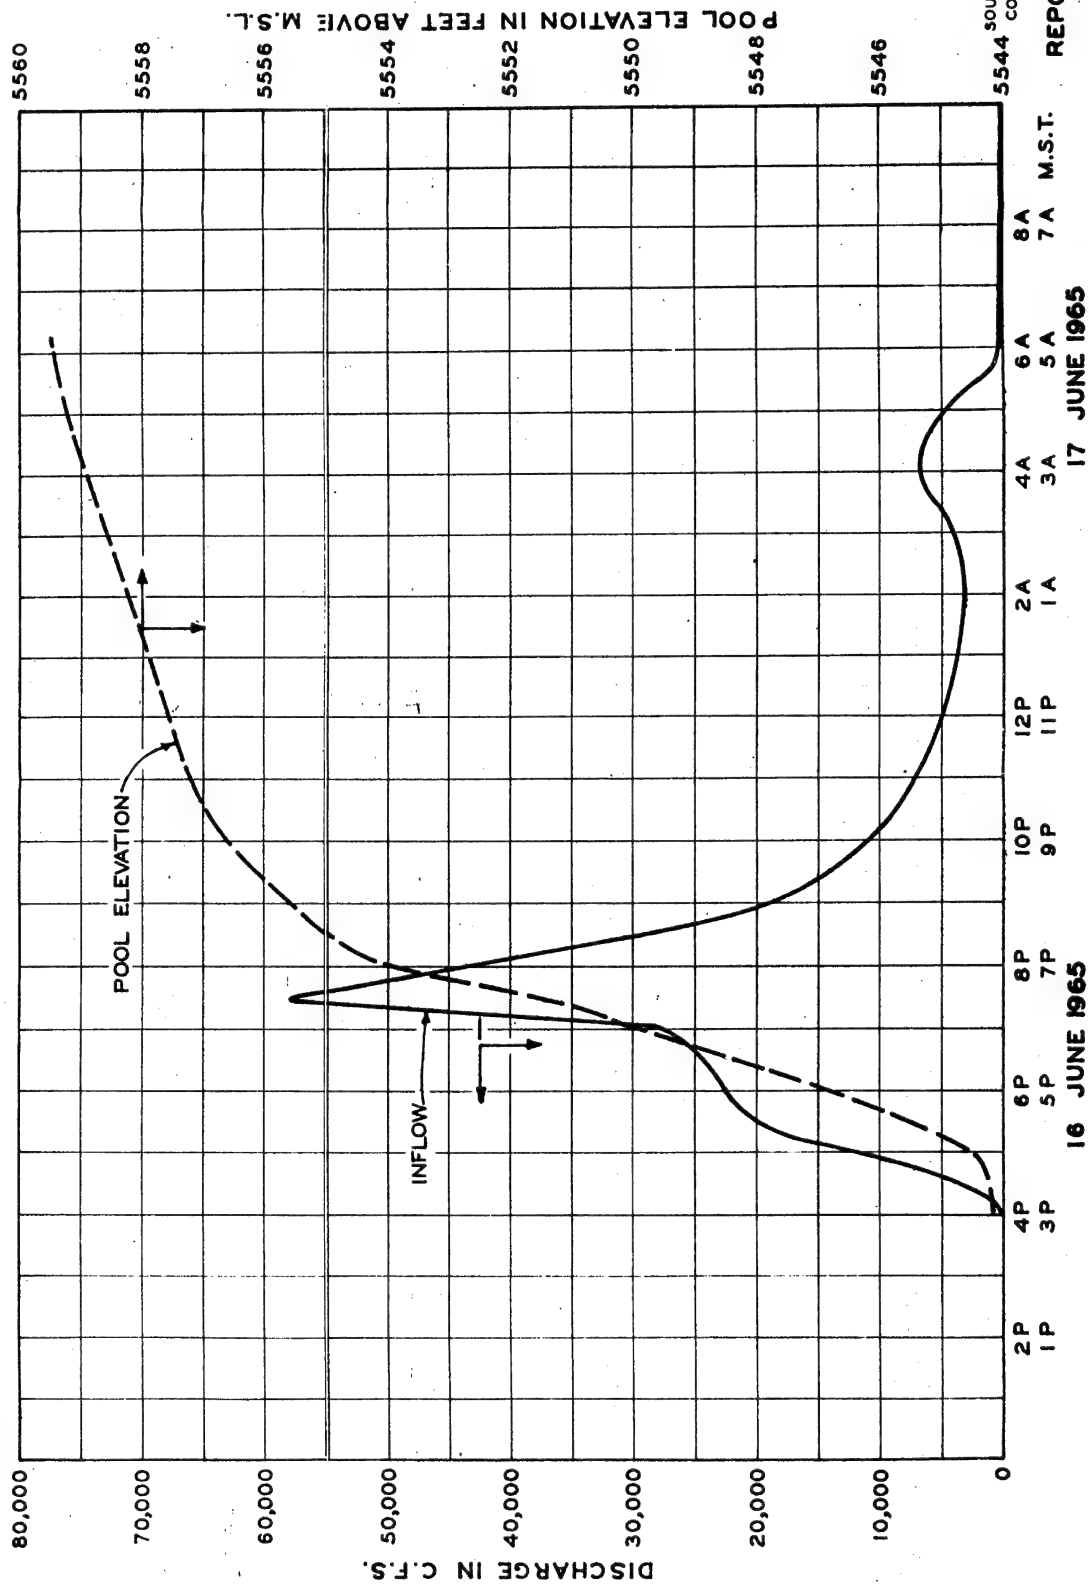
REPORT ON THE FLOODS
OF JUNE 1965
STORM OF 15-17 JUNE 1965
CHERRY CREEK RESERVOIR
INFLOW HYDROGRAPH
U. S. ARMY ENGINEER DISTRICT, OMAHA
CORPS OF ENGINEERS OMAHA, NEBRASKA
JANUARY 1967

(2) Had the flood occurred on the lower Cherry Creek channel, it would have carried away the 41 structures which cross the stream in the urban reach. These include six railroad bridges, 28 major city bridges, one pipeline and six foot bridges. Moreover, the higher flood stages on the South Platte River would have damaged or destroyed the remaining bridges over the river which were not destroyed by the South Platte River flood. The additional flood volume also would have increased flood stages considerably in the rural reaches downstream from Denver, and would have caused additional major damages to irrigation structures, irrigated lands, and roads and bridges in these reaches. However, the major damages would have been inflicted on the commercial and industrial properties along the Cherry Creek channel and the lower South Platte River valley in metropolitan Denver. The increased stages near the confluence of Cherry Creek and the South Platte River would have flooded vastly greater areas of central Denver and would have virtually paralyzed the metropolitan community. In addition to preventing much greater flood damages, Cherry Creek Dam retained a large volume of flood-borne debris which otherwise would have considerably increased the cost of cleanup operations in metropolitan Denver. Flood damages prevented by the Cherry Creek project are estimated at \$130 million. The inflow hydrograph at Cherry Creek Reservoir for the 16 June flood is illustrated on plate 7.

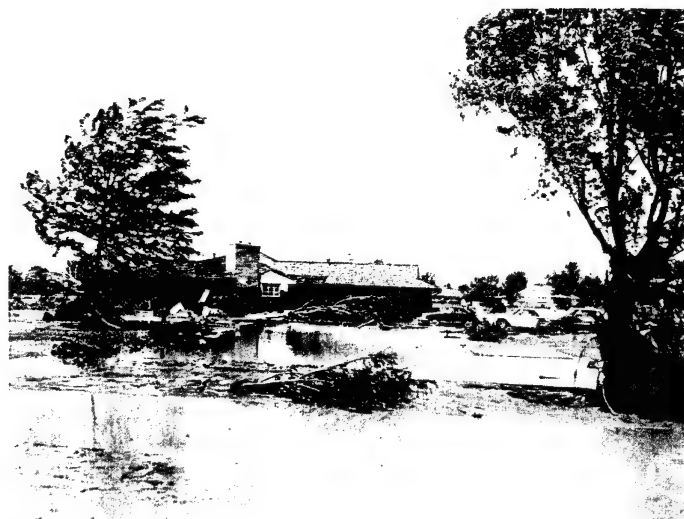
#2 Columbine Country Club area in southern part of metropolitan Denver. Two homes were washed from foundations shown in foreground and house shown was extensively damaged. Rear walls were destroyed and furniture was carried away. Note highwater mark on house.

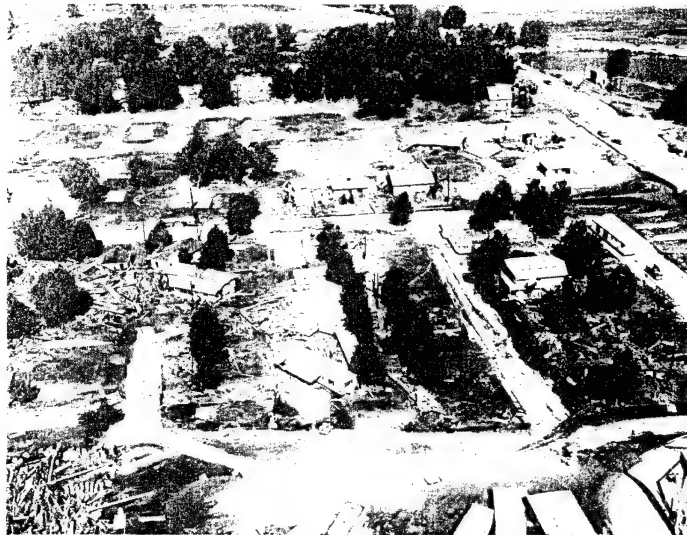
#3 Aerial view of damage and destruction in Littleton area of metropolitan Denver upstream of Bowles Ave. Foundations of destroyed homes can be seen in upper left part and damaged laundramat shown in photograph #4 can be seen in upper right part of photograph.

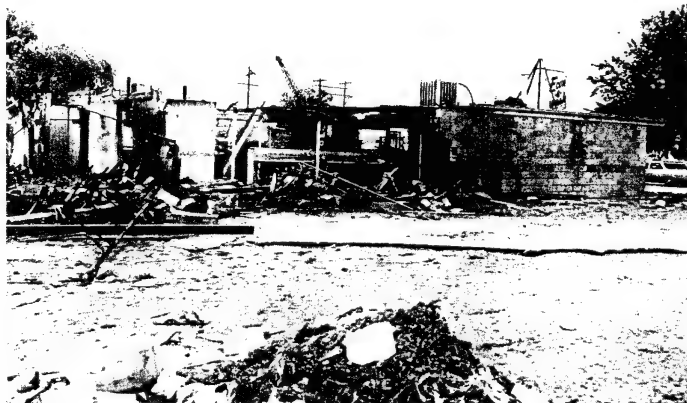
#4 New laundramat at Bowles Avenue in Littleton was demolished by floodwaters and then further damaged by fire.

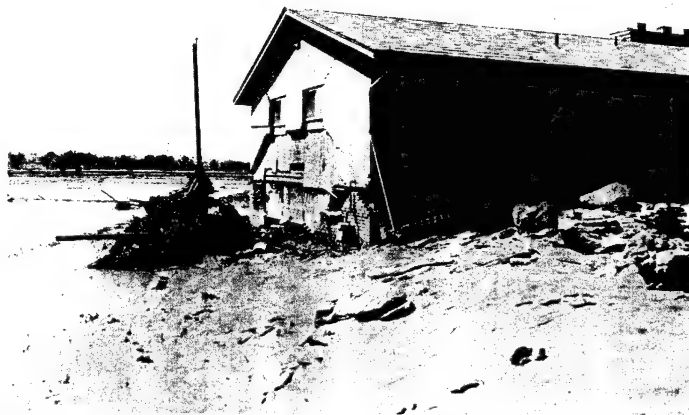
#5 Destructive force of flood is shown by house and yard damage at Bowles Avenue in Littleton area of south metropolitan Denver.

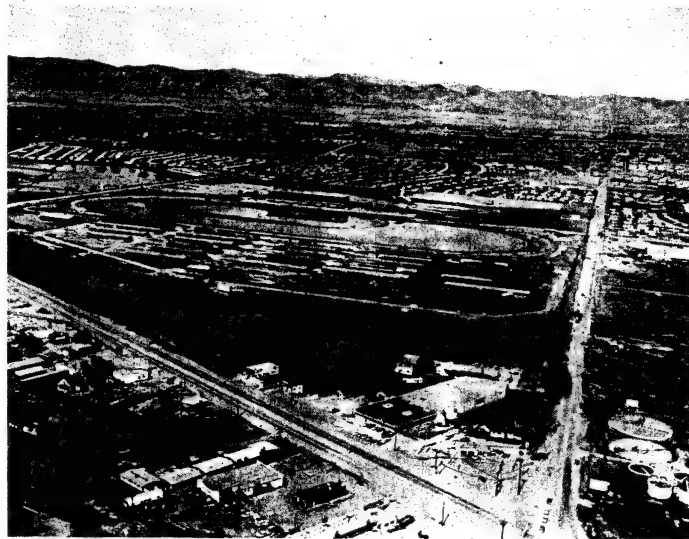
#6 General view of Centennial Race Track in southern metropolitan Denver showing remains of horse barns. Several barns were completely washed away and only 5 escaped structural damage. Several race horses were swept away with the barns.

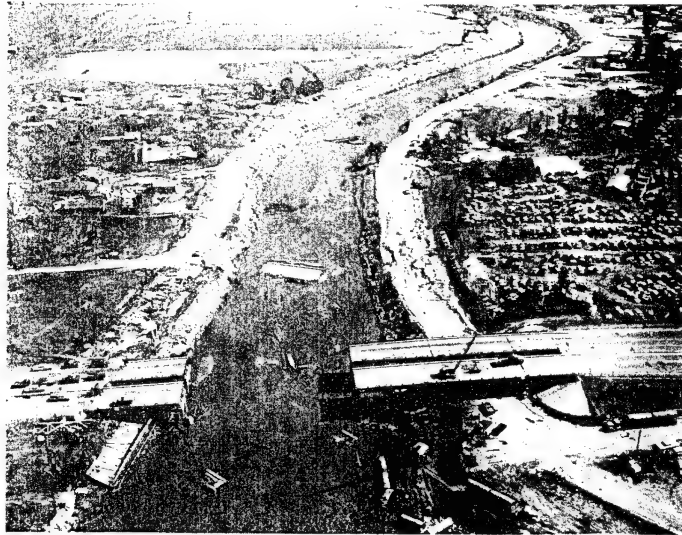
#7 Aerial view of damage at Hampden Avenue bridge at south city limits of Denver proper. Old span is shown lodged against left abutment of new bridge and part of new span is shown downstream in channel bed.

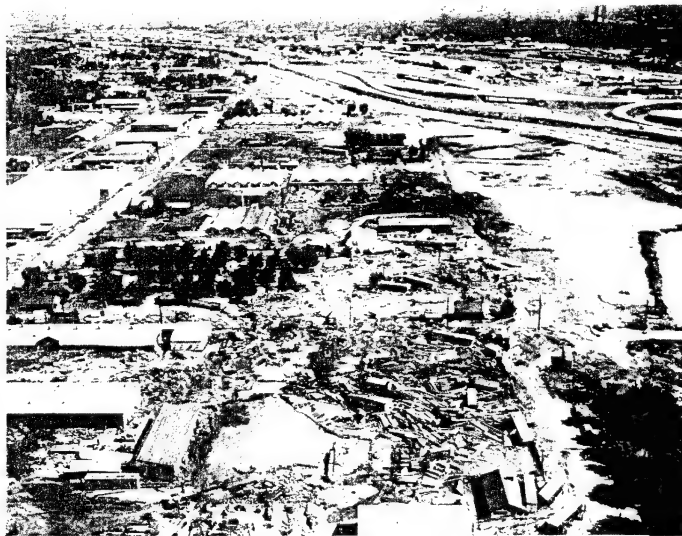
#8 View showing extent of damage in industrial area located north of Mississippi Avenue in Denver proper.

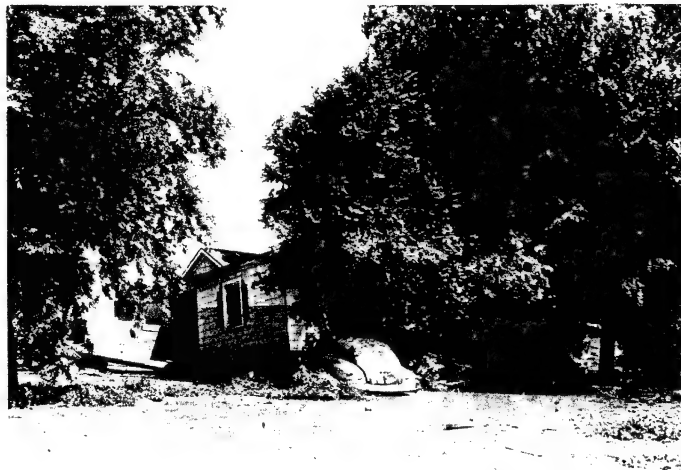
#9 View of house washed from foundation and left on top of cars upstream of Alameda Avenue in Denver proper. Note highwater mark on house.

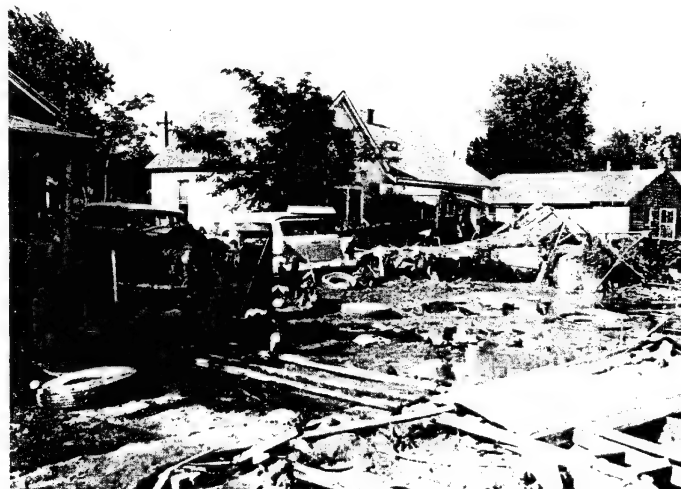
#10 View of damage and debris left in the vicinity of Byers Place, downstream of Alameda Avenue in Denver proper.

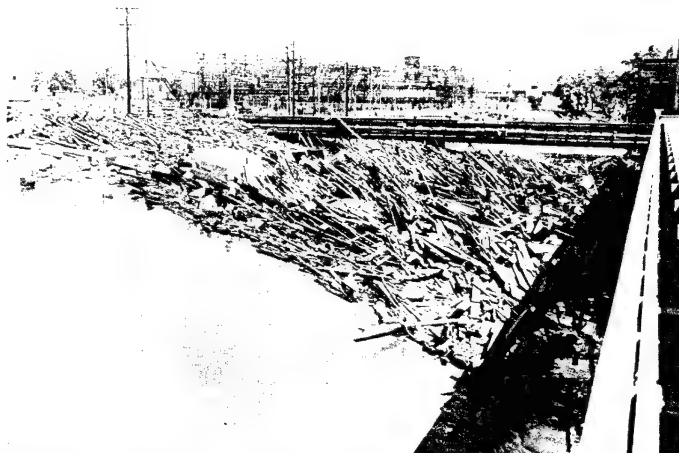
#11 View of debris lodged at 13th Avenue bridge in Denver proper. Truck can be seen in center photograph.

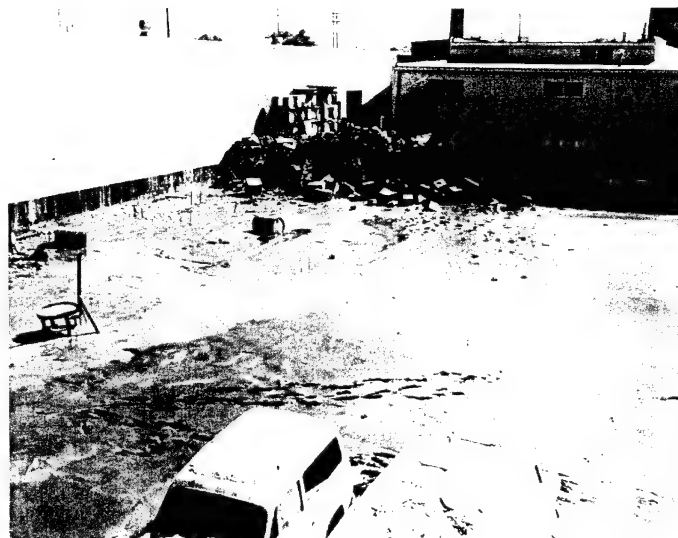
#12 Damage and debris at paint warehouse on left bank of South Platte River between 8th and 9th Streets in Denver proper. Note highwater marks on warehouse and over top of cars.

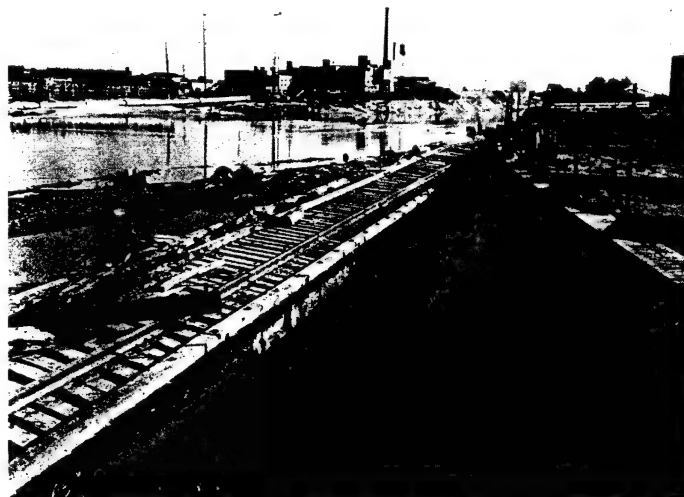
#14 Damage to railroad crossing at north city limits of Denver at Franklin Street. Former location of bridge can be seen at upper part of photo

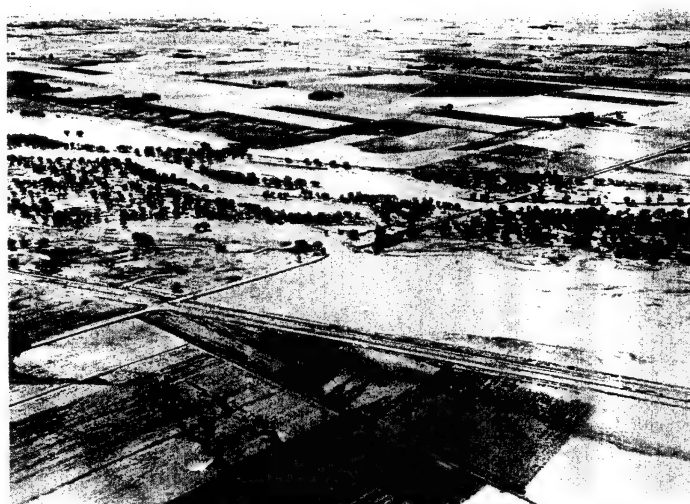
#15 Extent of bridge road and area flood damage along the South Platte River 4 miles downstream of Fort Morgan, Colorado. Highwater marks can be seen on both banks.

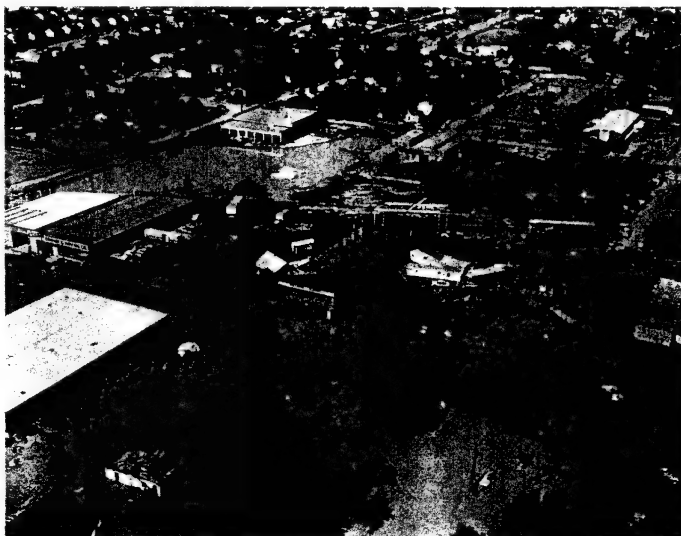
#20 Warehouses and garages damaged by the flood waters. Note high water line at the top of the first story windows on garage in center of photograph.

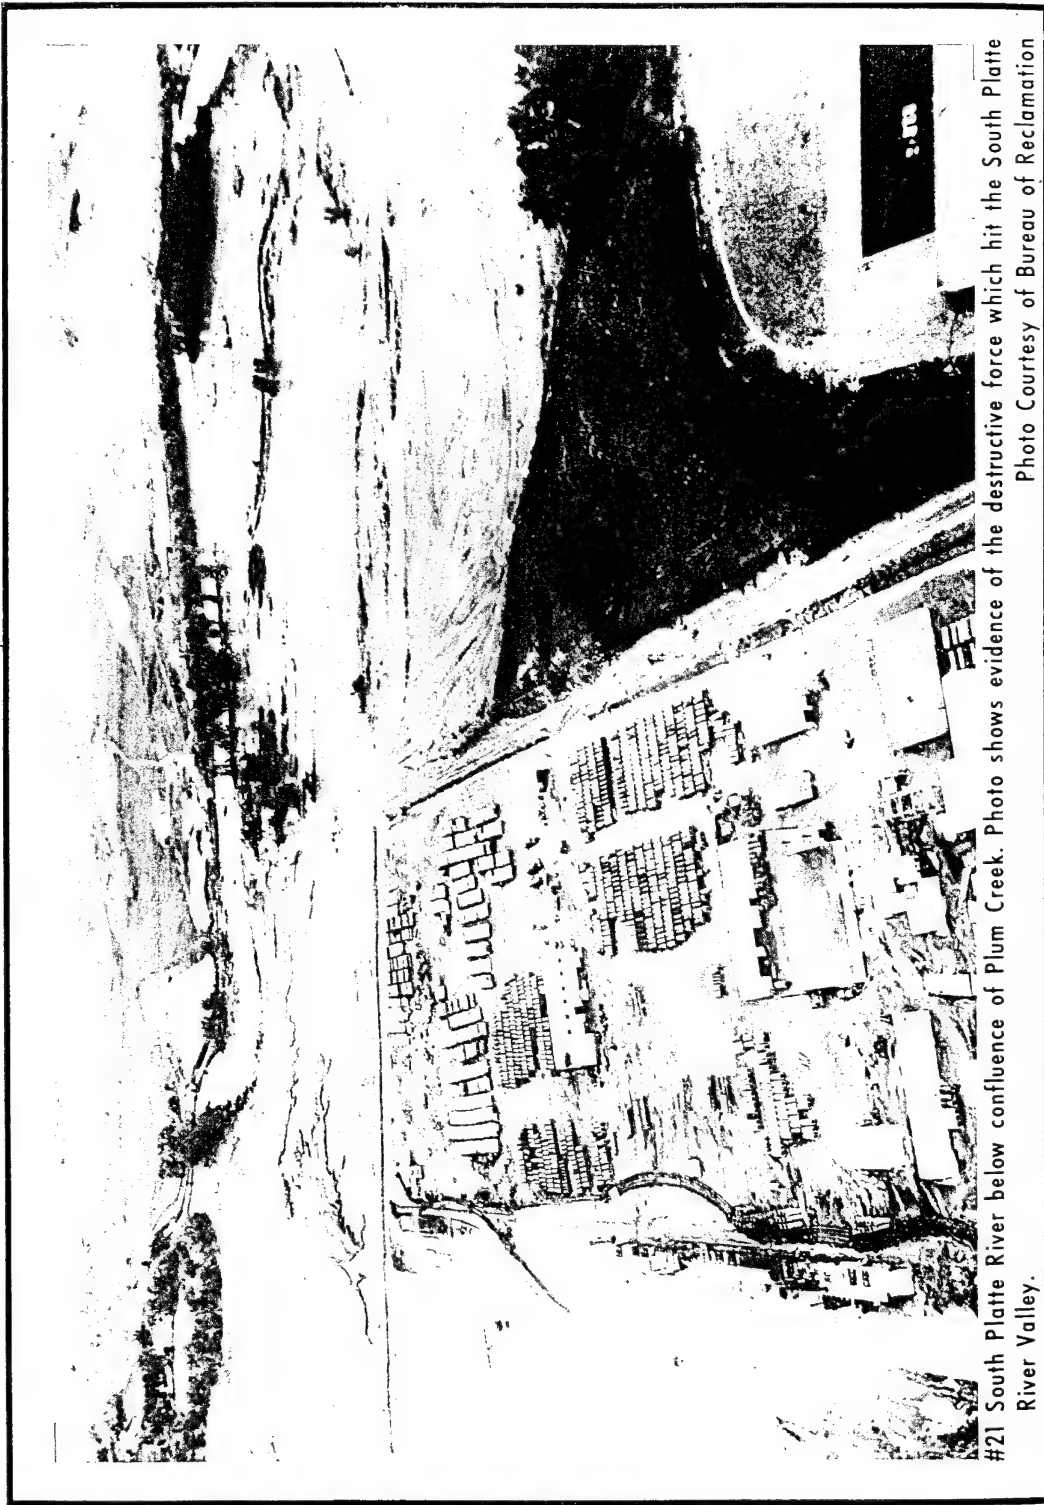
#21 South Platte River below confluence of Plum Creek. Photo shows evidence of the destructive force which hit the South Platte River Valley.
Photo Courtesy of Bureau of Reclamation
